# Module 9: Troubleshooting

Slides adapted from Cepheid

# GeneXpert Instrument: Problems that may be encountered

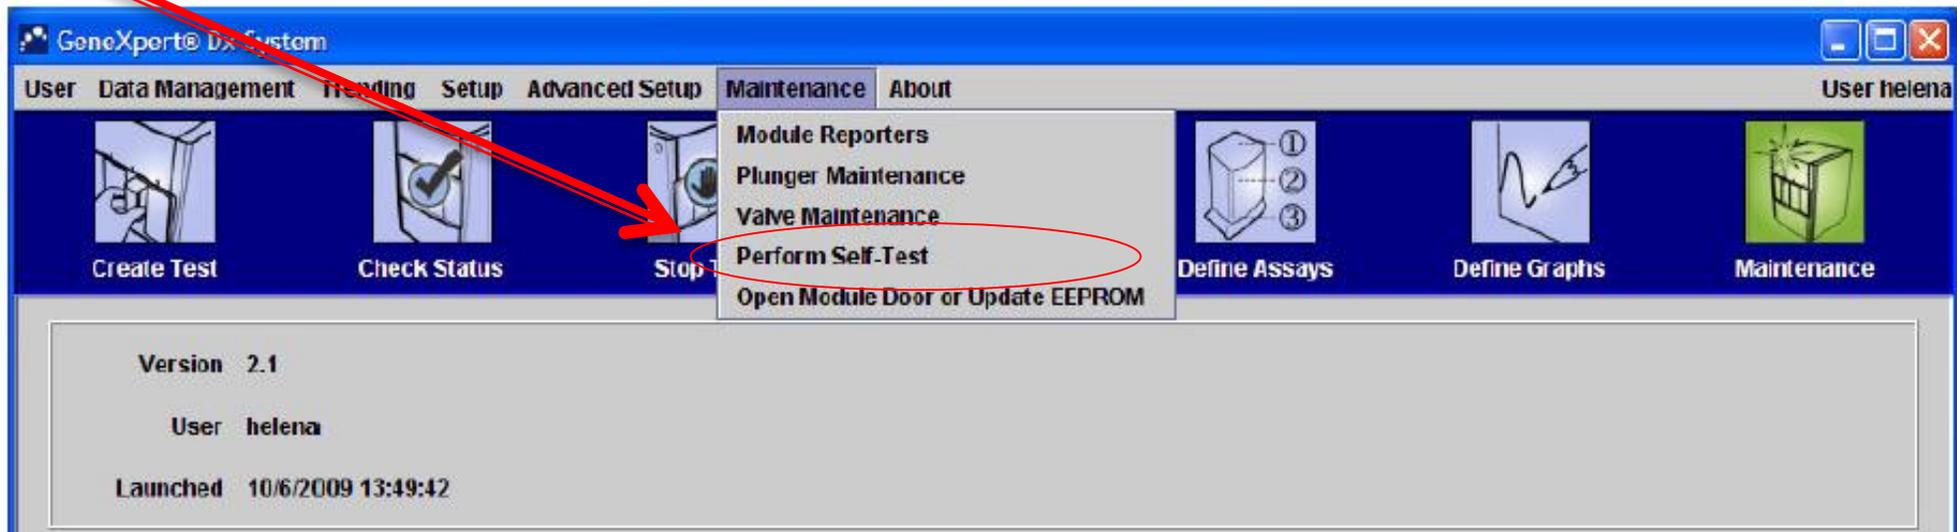
# Red Light on Module Blinking

- ▶ This indicates that the module may be failing
- ▶ In the GeneXpert Dx System window, click “Maintenance” on the menu bar and select “Perform Self-Test”
- ▶ If problem persists, contact **Cepheid Technical Support**

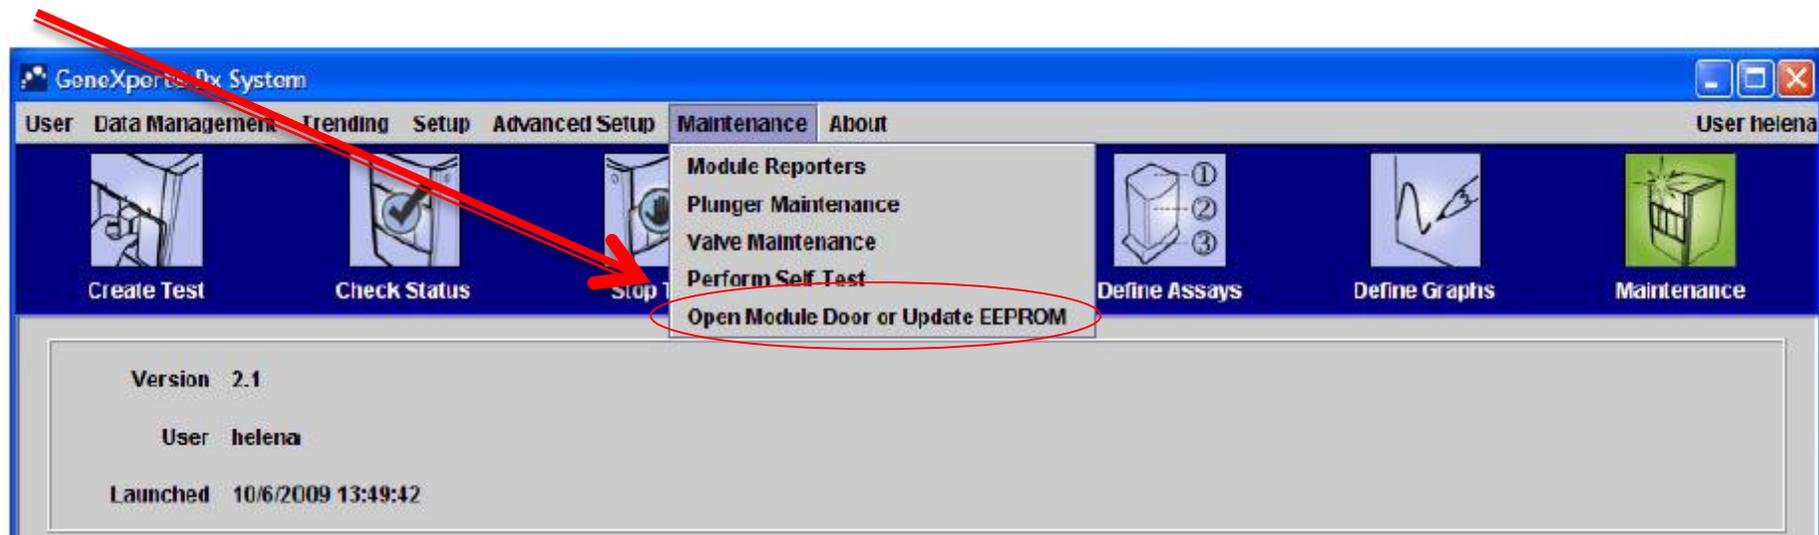
# Cartridge Stuck in GeneXpert (1)

- ▶ **Solution 1:** Verify that module door is not open
  - Gently try to open module door.
- ▶ **Solution 2:** In the GeneXpert Dx System window, click “Maintenance” on the menu bar and select “Open Module Door or Update EEPROM”

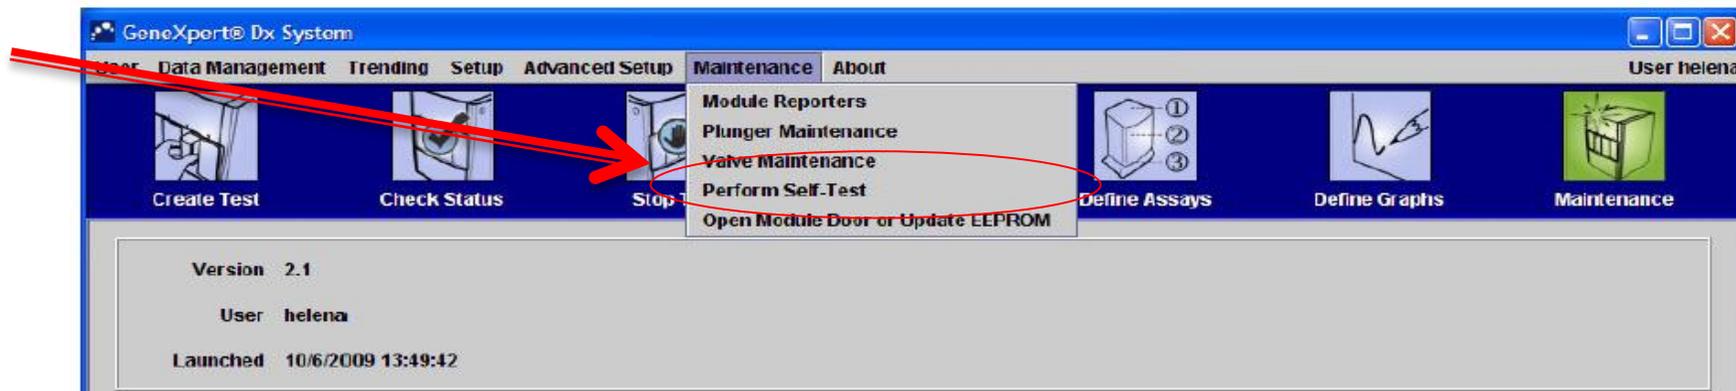
# Cartridge Stuck in GeneXpert (2)

- ▶ **Solution 3:** Close the software, and re-launch the software
  - When the software is re-launched, the module will reinitialize itself, by putting the valve and the syringe in correct position. This may help to open the door.
- ▶ **Solution 4:** Turn the system off and restart both GeneXpert instrument and software
- ▶ **Solution 5:** In the GeneXpert Dx System window, click “Maintenance” on the menu bar and select “Perform Self-Test”

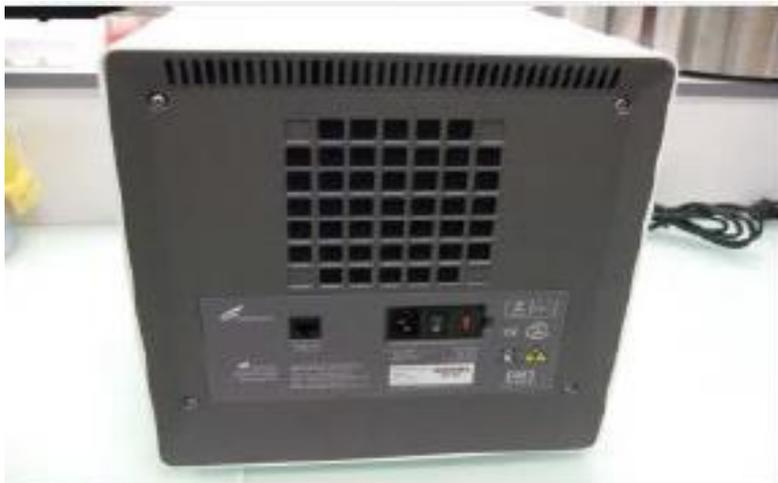
## 1. Disconnect GeneXpert Instrument

1. Disconnect the instrument from electrical sources and the computer

Be careful not to turn the instrument upside down or the cartridge content could leak inside the instrument and damage the module (which will need to be replaced).

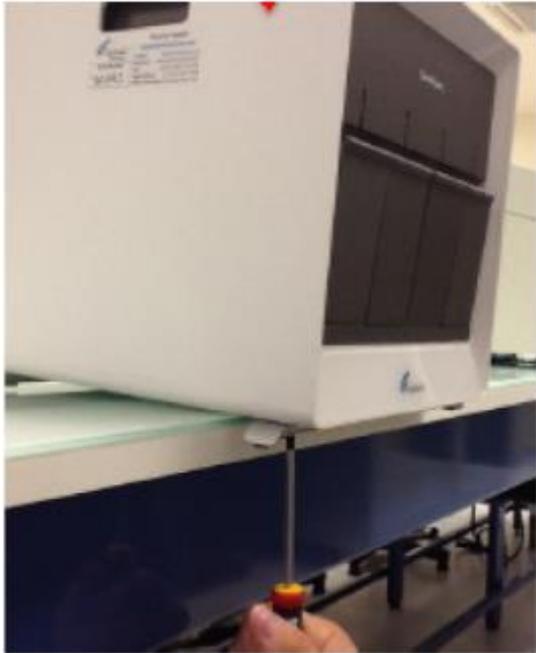
2.1: Remove all 3 screws from each foot underneath the GeneXpert machine

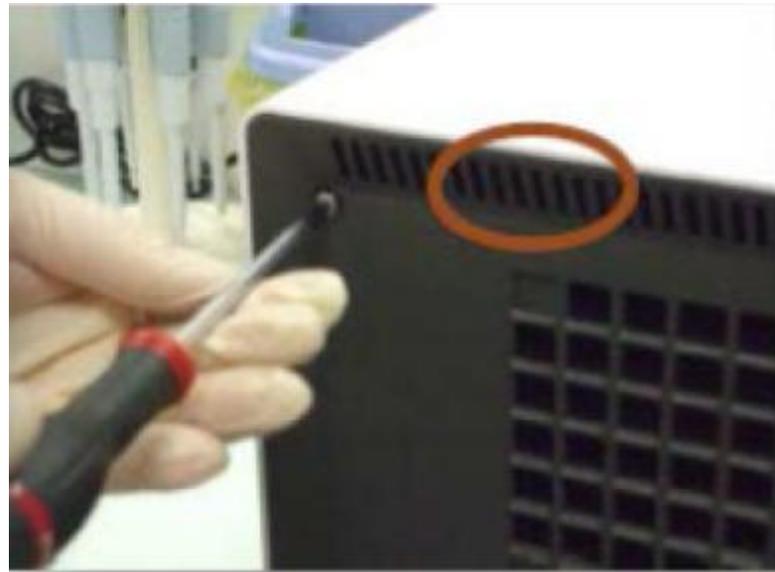
2.2: Remove all 4 screws from the back cover. If necessary, pliers can be used to remove back over by gripping the area indicated above. Avoid using the fan vent located below as this can damage the fan

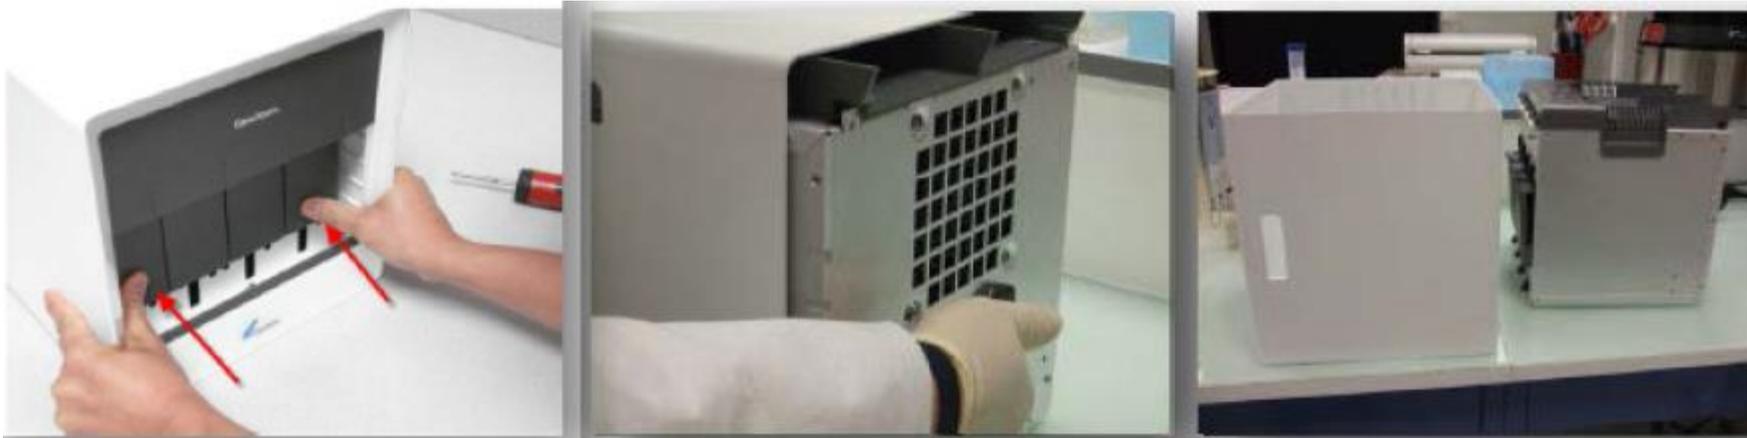
2.3: Carefully pull the device out of the outer casing while pushing on the doors of the device

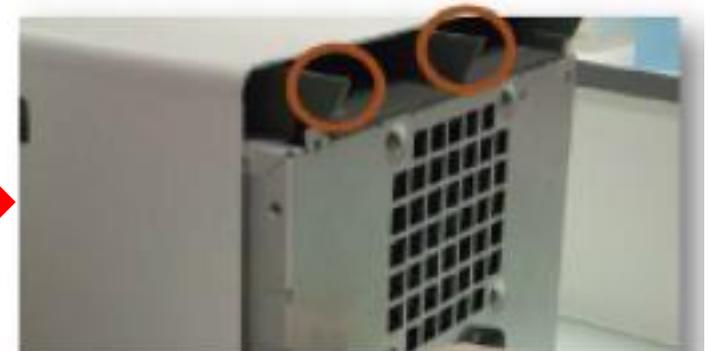
**CAUTION: SHARP EDGES!** The corners indicated in the figure are sharp and can cause injury if care is not taken!

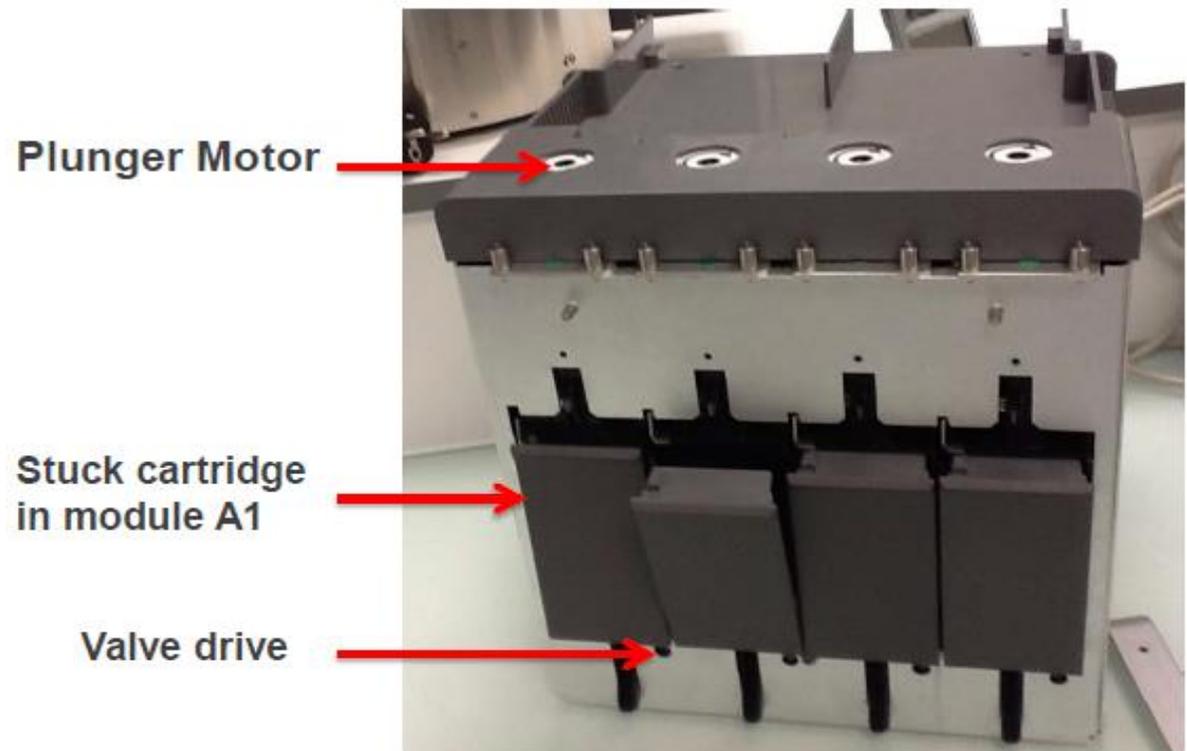
## 3. Manually Remove Stuck Cartridge

3. At this stage, there are 2 options to remove the stuck cartridge:

Option 1: Move up the Plunger

Option 2: Turn valve in the correct position

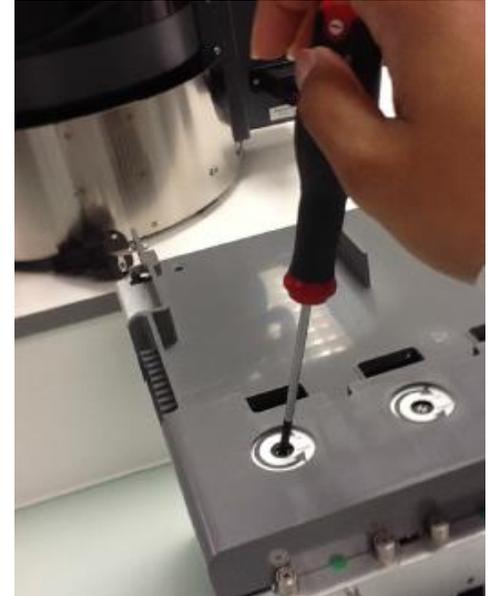
### Option 1: Move up the plunger

- A. Screw the plunger back to correct position by turning the screw in the “UP” direction.
- B. Try to open the door.

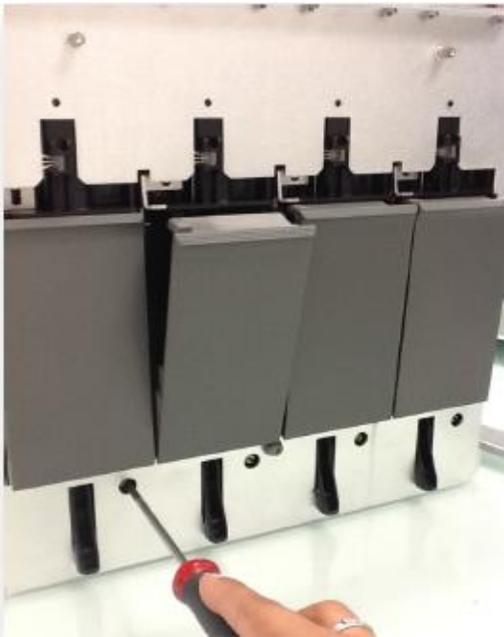
### Option 2: Turn valve in correct position

- A. Screw slowly in one direction while trying to open the door. Be aware that it may take a while.
- B. Eventually the valve will go back in correct positioning, the door will open and you will be able to remove the cartridge.

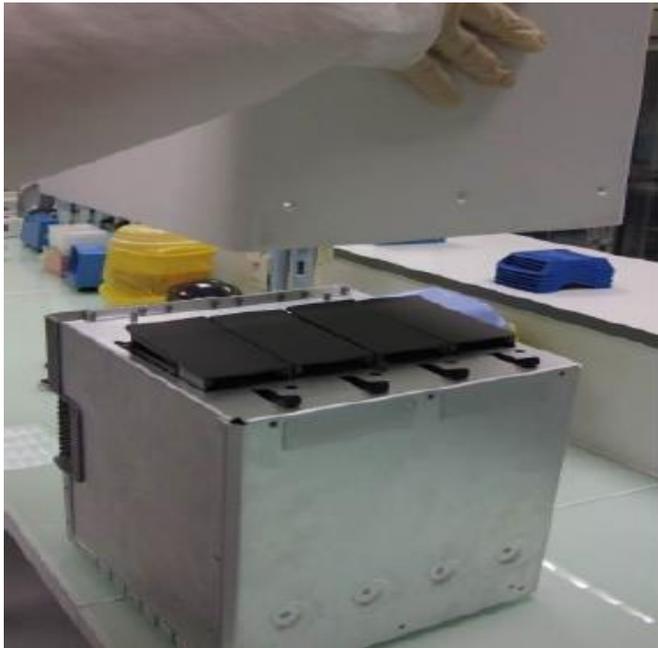
4.1. Place the instrument carefully on its back and lower the outer casing over

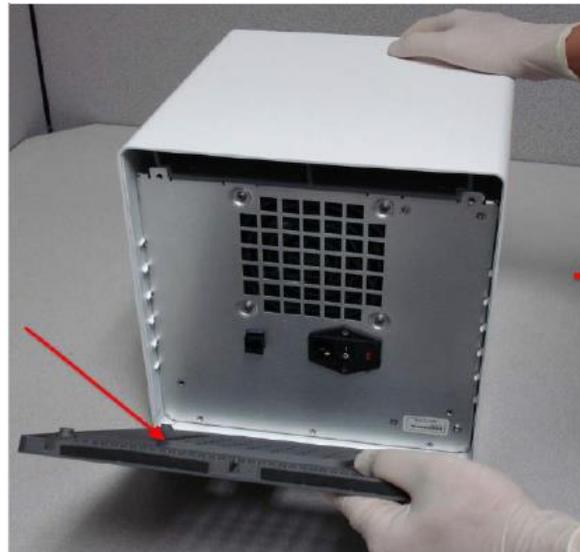
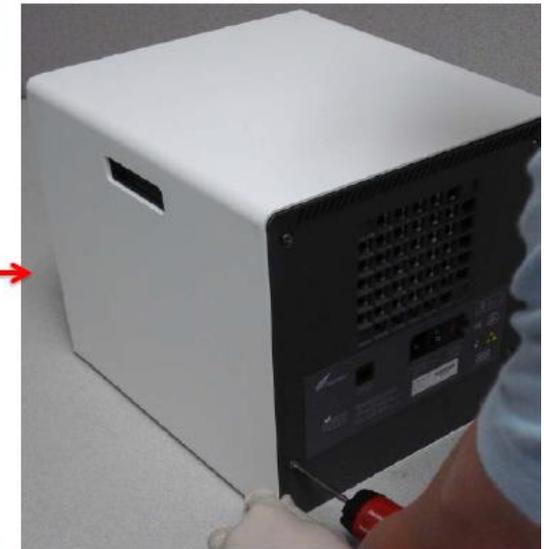
4.2. Place back the backside and screw back all 4 screws (not too tight!)

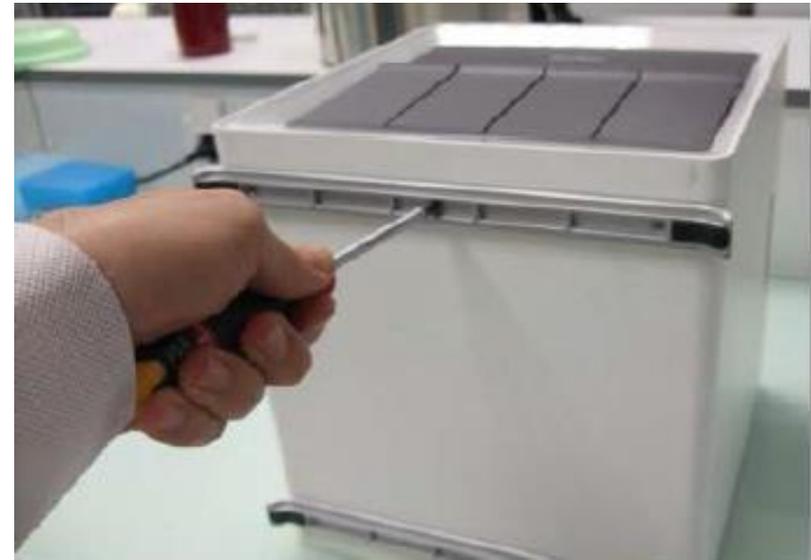
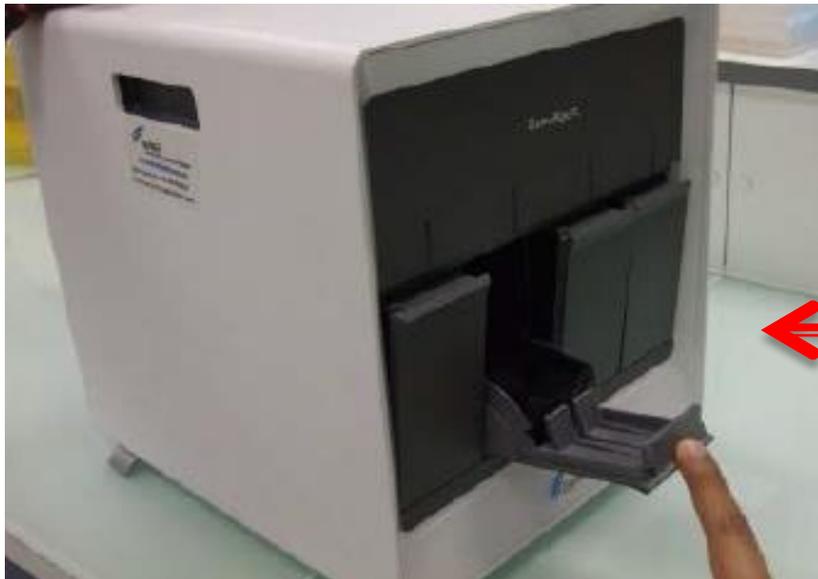
4.3. Screw back all 3 screws of each foot underneath the GeneXpert

After reassembly, if the doors become difficult to open or close, then the front feet have been screwed on too tightly.

→ loosen the screws of the front feet until the door opens freely

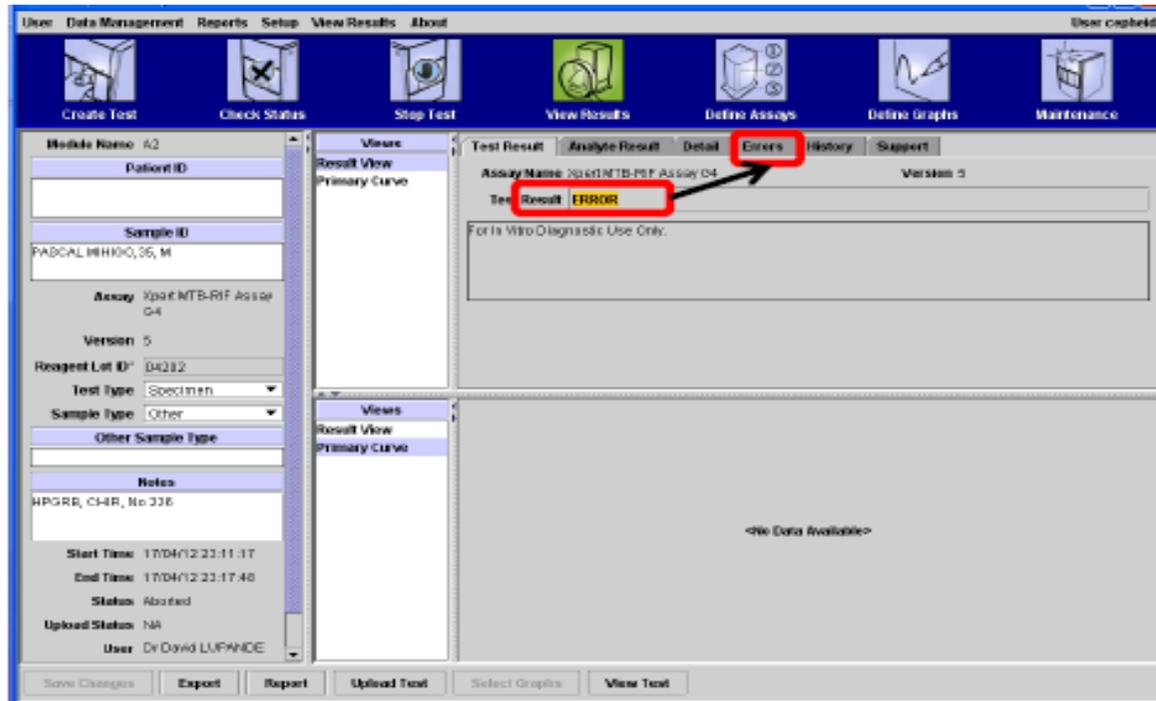
# Understanding Error Codes

## Cause(s)

Many different causes can lead to an ERROR result. Click on “Errors” to learn more about the issue.

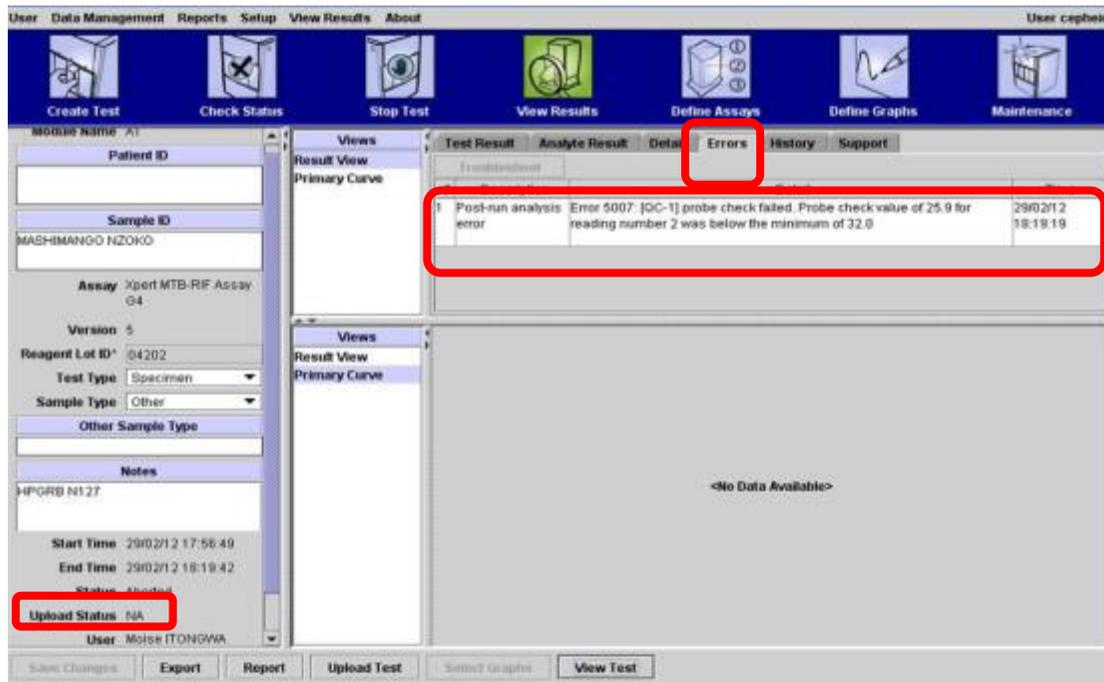
# Error Code: 5006 / 5007 / 5008

Probe Check Control failed and test was stopped before amplification.

Sample too viscous and/or wrong sample volume added to cartridge; Cartridge reaction tube improperly filled, contains bubbles, or probe integrity issues detected.

After 15 (10+5) minutes of decontamination, if the sample is still too viscous do not load it into the cartridge. Wait up to 10 additional minutes until the sample is totally liquefied, then transfer it into the cartridge using a new disposable pipette. The transferred volume into the cartridge should be between 2 and 4 mL max.

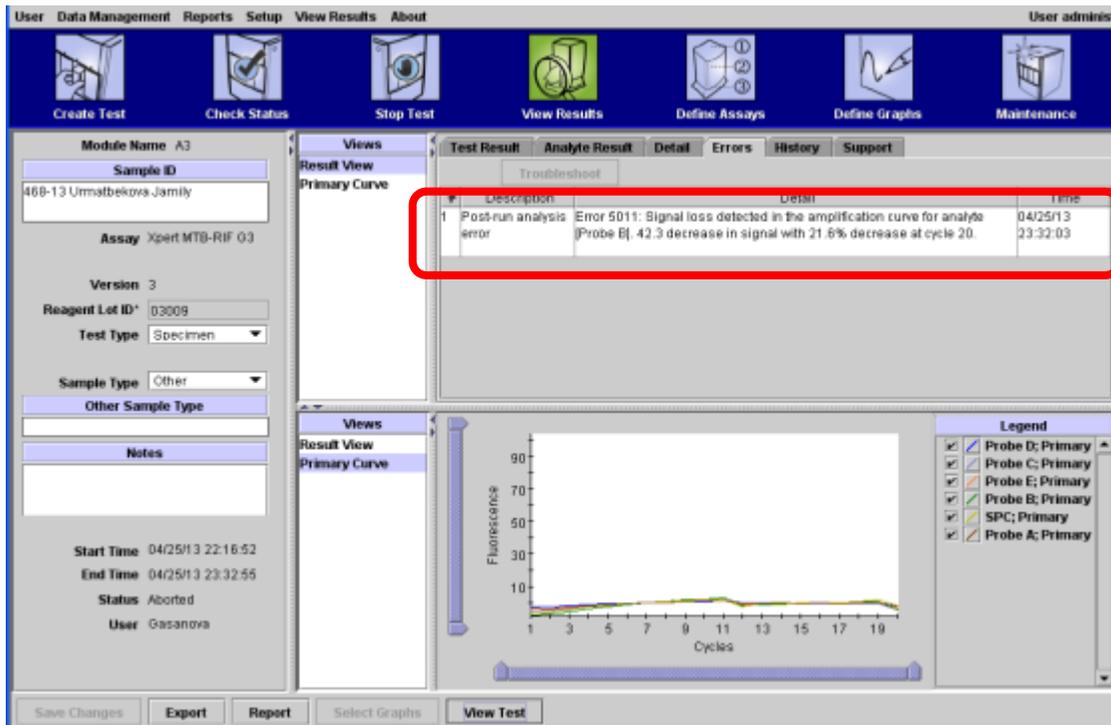
# Error Code: 5011

Signal loss detected in the amplification curve.

Loss of tube pressure because the cartridge tube is not airtight or cartridge valve is not working correctly.

Repeat the test using a new cartridge. If error persists, it can be module related; i.e., the module fluidics may not be working. Contact **Cepheid Technical Support**.

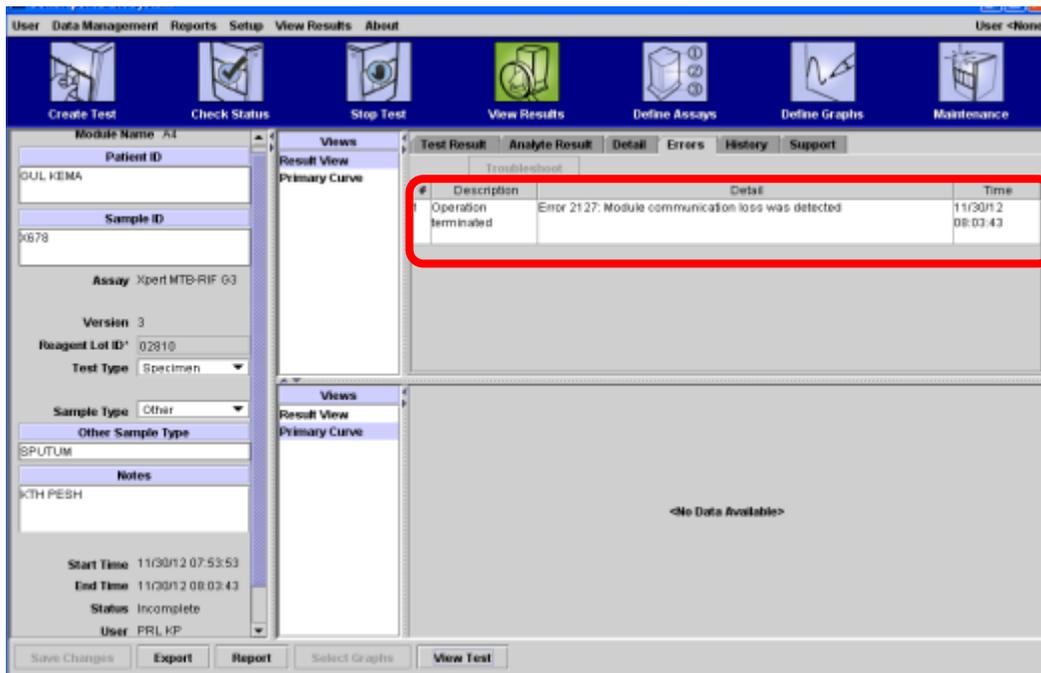
# Error Code: 2127

Module communication loss was detected.

Power supply issue (main power or UPS fluctuations/failure).

- Unplug and plug again the Ethernet cable between computer and instrument.
- Unplug and plug again the communication cable between gateway board and GeneXpert.
- Restart system and check temperature (should be below 30°C).
- Check the functioning of the UPS and install a surge protector.

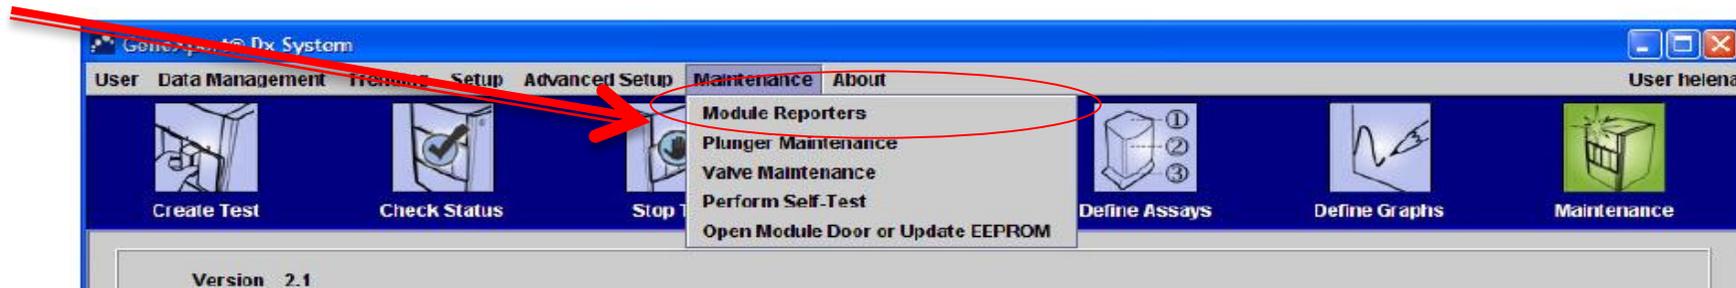
# Other Error Codes

- ▶ **Error 2037:** Cartridge integrity testing
  - At the early beginning of a test, the GeneXpert checks the pressure inside the tube. If pressure is not correct, the software will stop the test because the cartridge is not airtight (quality issue). Do not use that cartridge.
- ▶ **Error 2014/ 3074/ 3075/ 1001:** temperature/heater failure
  - Causes: high temperature in module; heater component failure; broken fan; dust on filter near fan
  - Does this error affect only one module? Always the same?
    - In the GeneXpert Dx System window, click “Maintenance” on the menu bar and select “Module Reporters” to check module temperatures

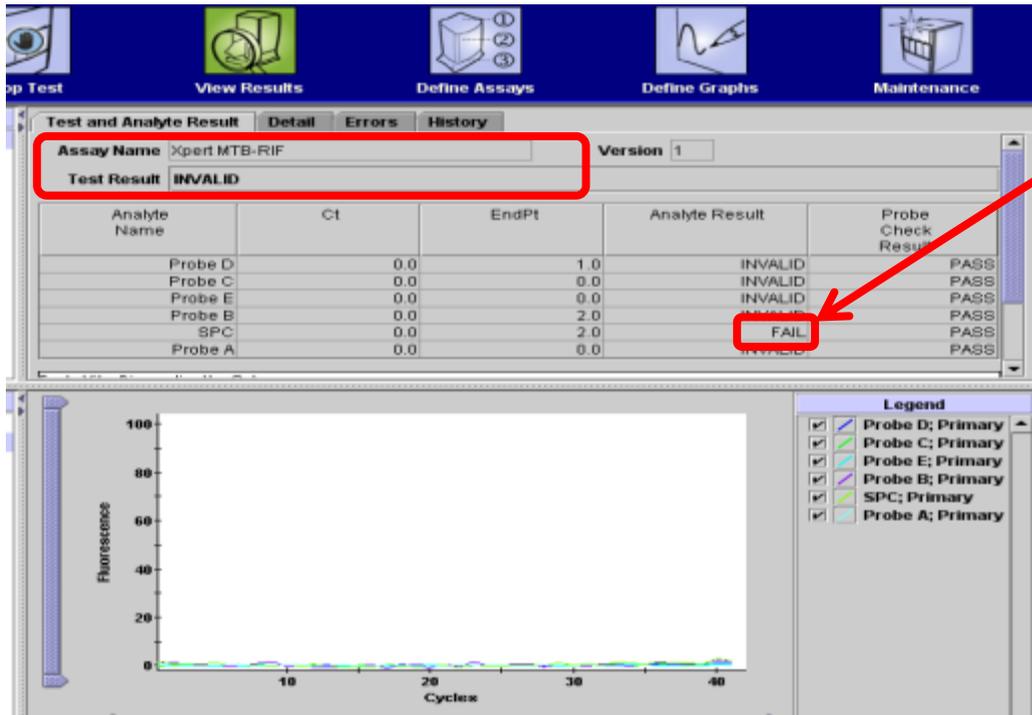
# Invalid Result

Sample Processing Control (SPC) failed.

PCR was inhibited due food particles or blood in the sample.

Before mixing with sample reagent (SR) for decontamination, check whether the sample contains food particles or blood. Allow food particles to settle to bottom of specimen before adding sample to cartridge.

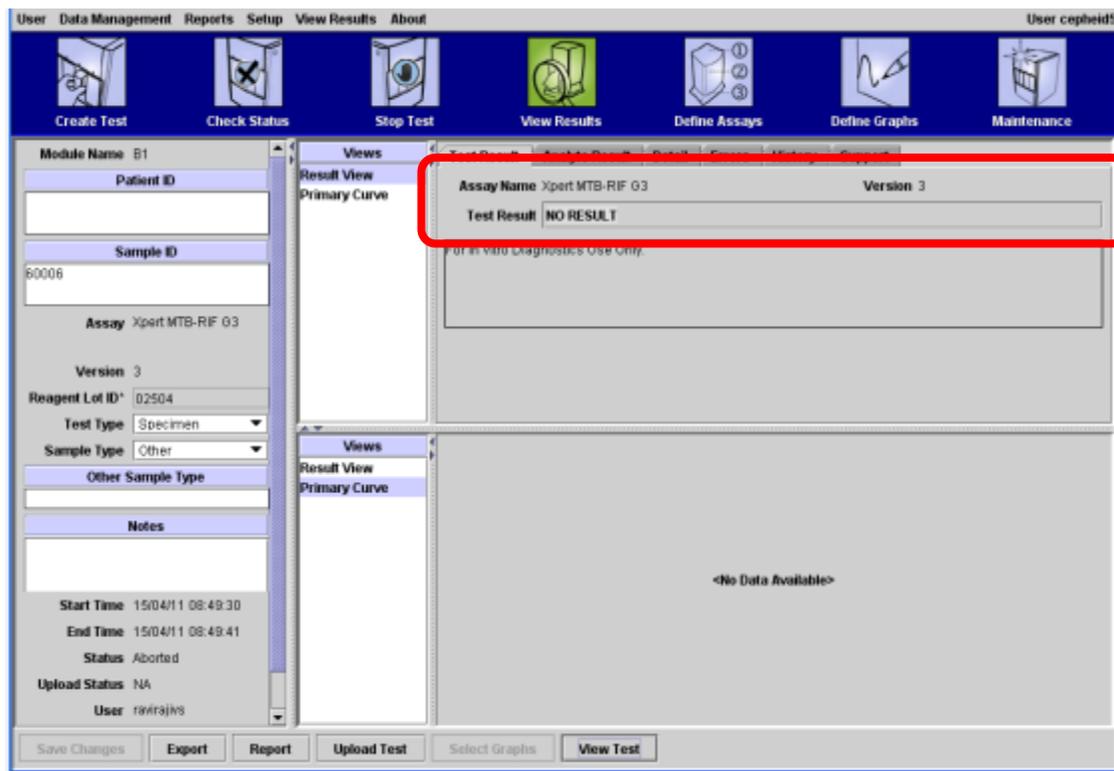
# No Result

Test could not be completed and insufficient data were collected.

Software stops working before test is completed due to:

- Windows or software freeze
- Power failure
- STOP TEST function was activated (accidentally , or deliberately)

Secure the power supply, restart the machine and repeat test with new cartridge. Contact Cepheid if the problem persists.

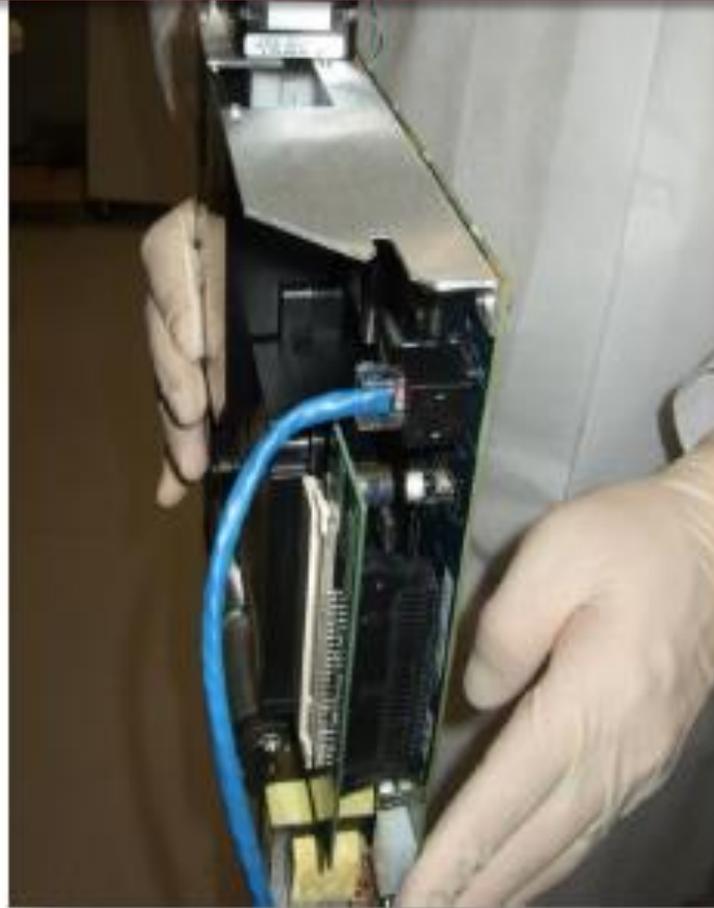
# Module replacement (swap)

Module replacement can only be done by Cepheid local service provider or a trained expert

3. Receive module(s)
4. Disinfect old module(s): instrument surfaces, cartridge bay, plunger rod
5. Replace (swap) module(s) – *Contact Cepheid Technical Support for help if needed*
